Report Date: July 24th, 2024

Report Number: 225523

Carson Farm  
125 Sugar Lake Rd,  
Lumby, BC

**Re: Warning Letter**

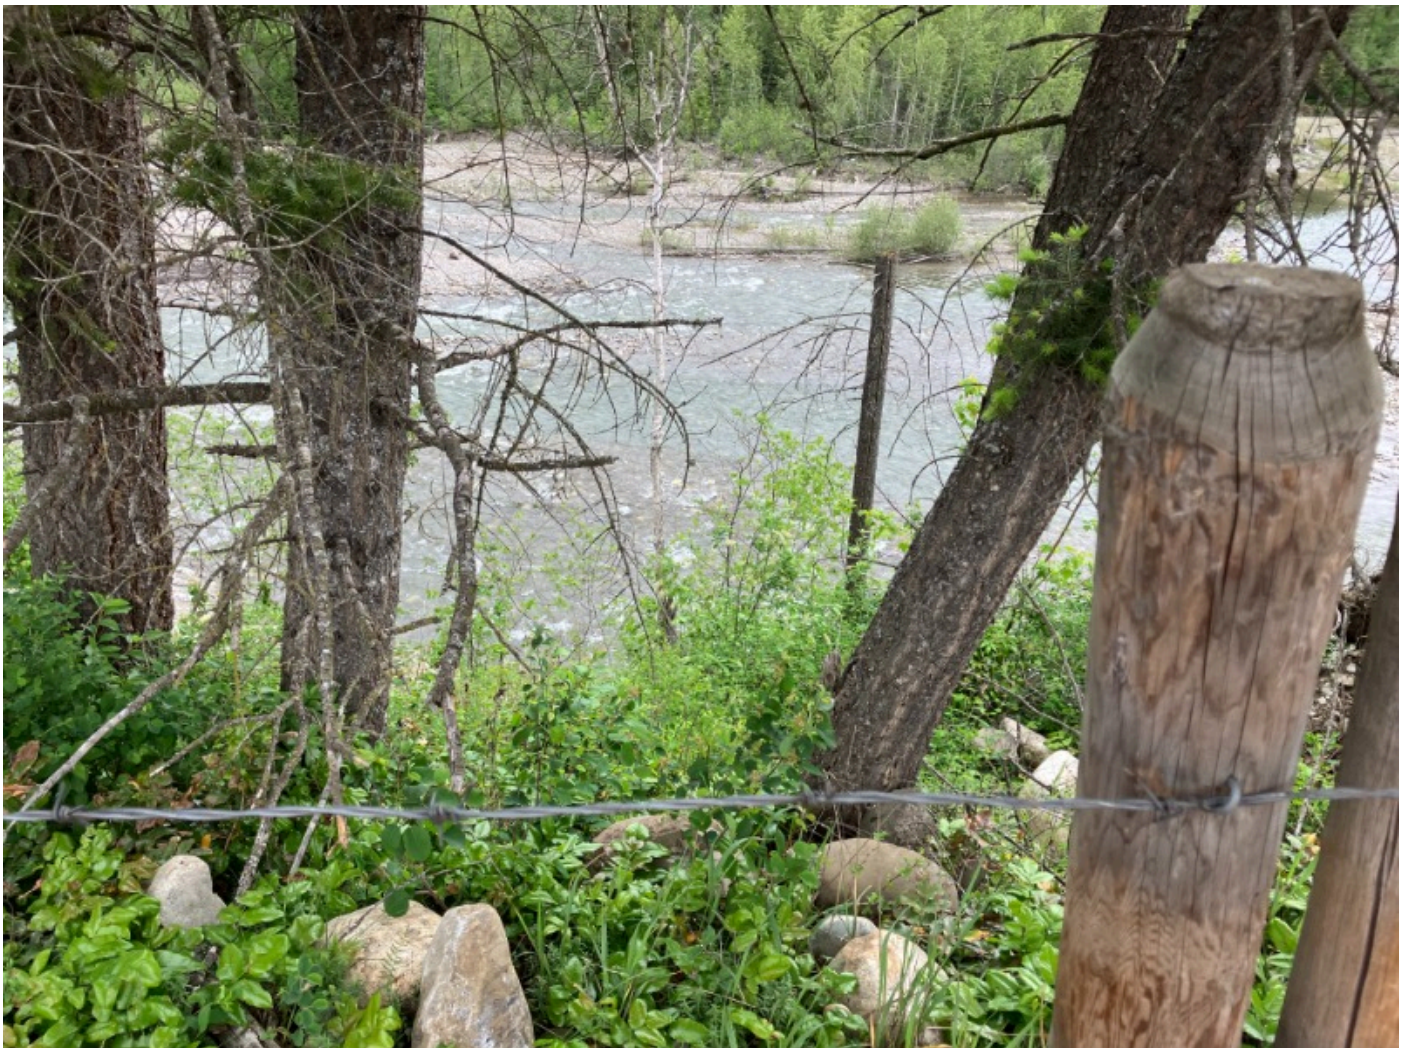
During the on-site inspection, Ministry Staff observed that the confined livestock areas in which animals are fed, containing more than 10 animal units were within the minimum 30 metres setback requirements of a watercourse other than a drinking water source, specifically Cherry Creek (Photo 1 and 2).

Photo 2. Boundary of confined livestock area within 18 metres of Cherry Creek, viewing northeast of the property.

Carson Farm must ensure the minimum setbacks required under Section 17(5) are met when rearing or keeping livestock

using a confined livestock area of which animals are fed.

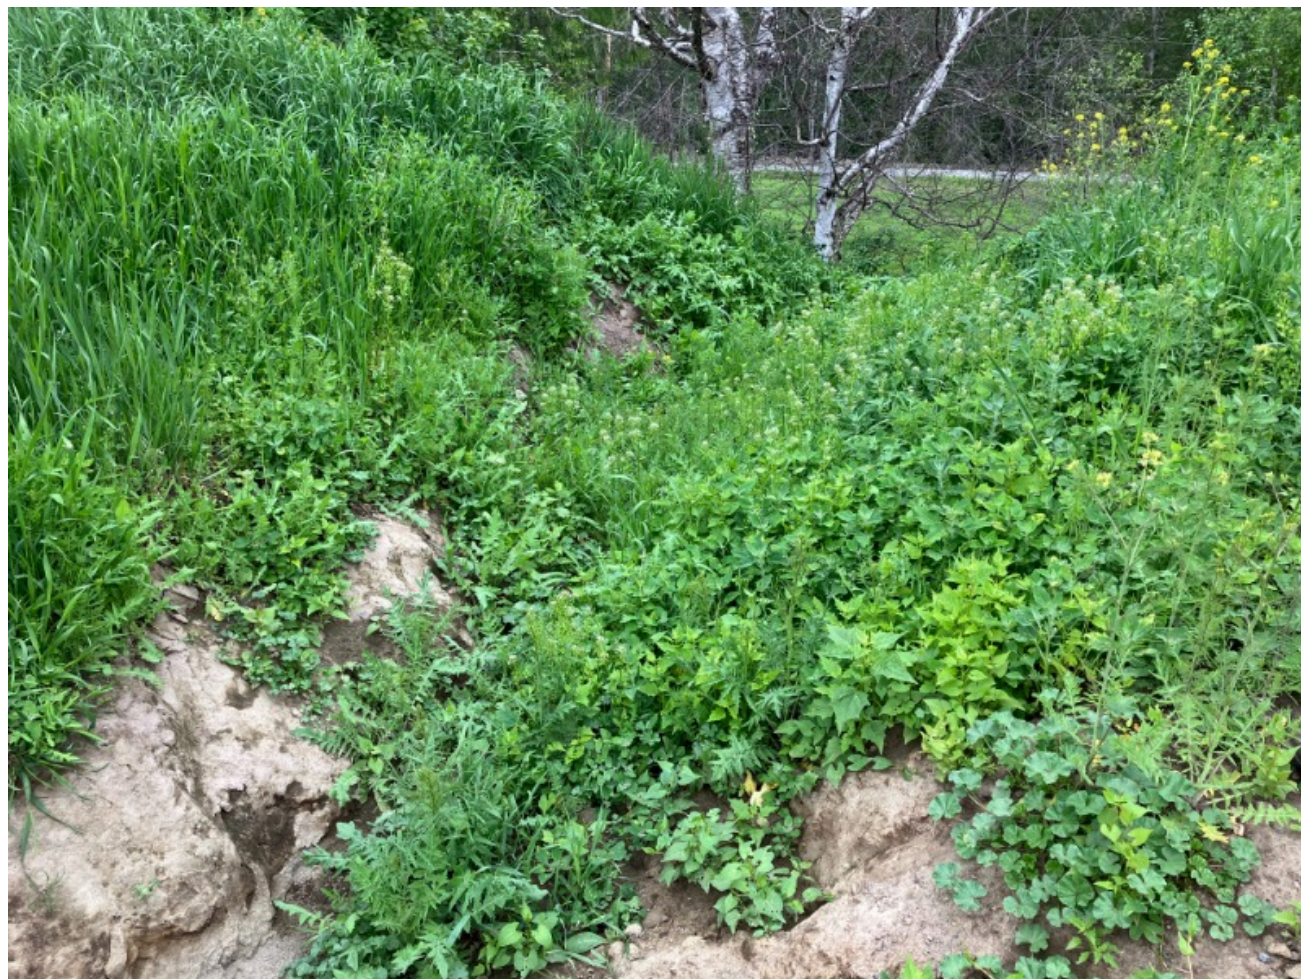
During the on-site inspection, Ministry Staff observed a drainage pipe (Photo 3) capable of discharging contaminated runoff from a confined livestock area to a ditch (Photos 4 and 5) and crossing a property boundary northwest of the Facility (Photos 1 and 6).

Photo 4. Westward bank adjacent to the confined livestock areas, where the drainage pipe enables contaminated runoff to escape.

Also considering the presence of a westward bank adjacent to the confined livestock areas, Carson Farm must contain and collect contaminated runoff, and not discharge contaminated runoff or solids directly into the land or water.

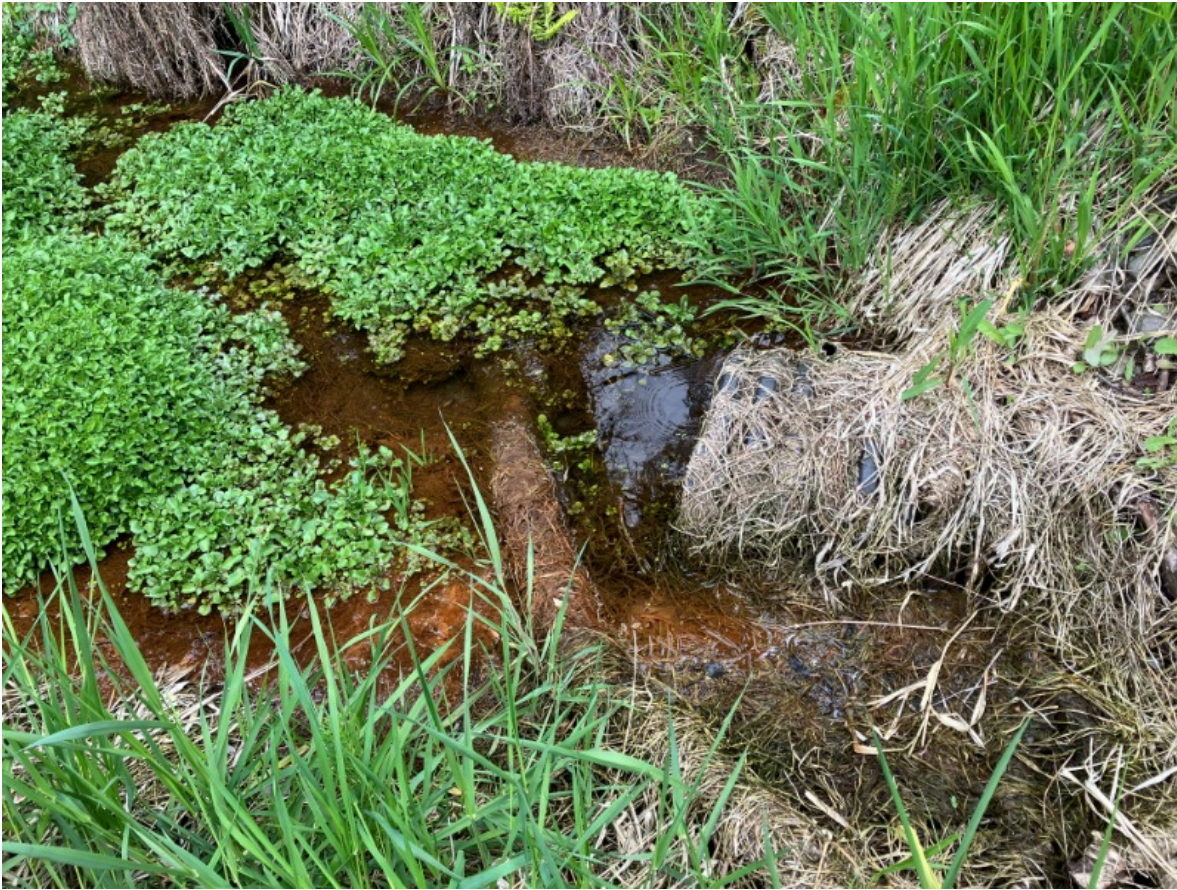
Photo 5. Ditch with culvert where the contaminated runoff crosses the neighbouring property boundary.

Carson Farm must immediately cease the discharge of contaminated runoff, leachate and solids from entering a watercourse or crossing a property boundary.

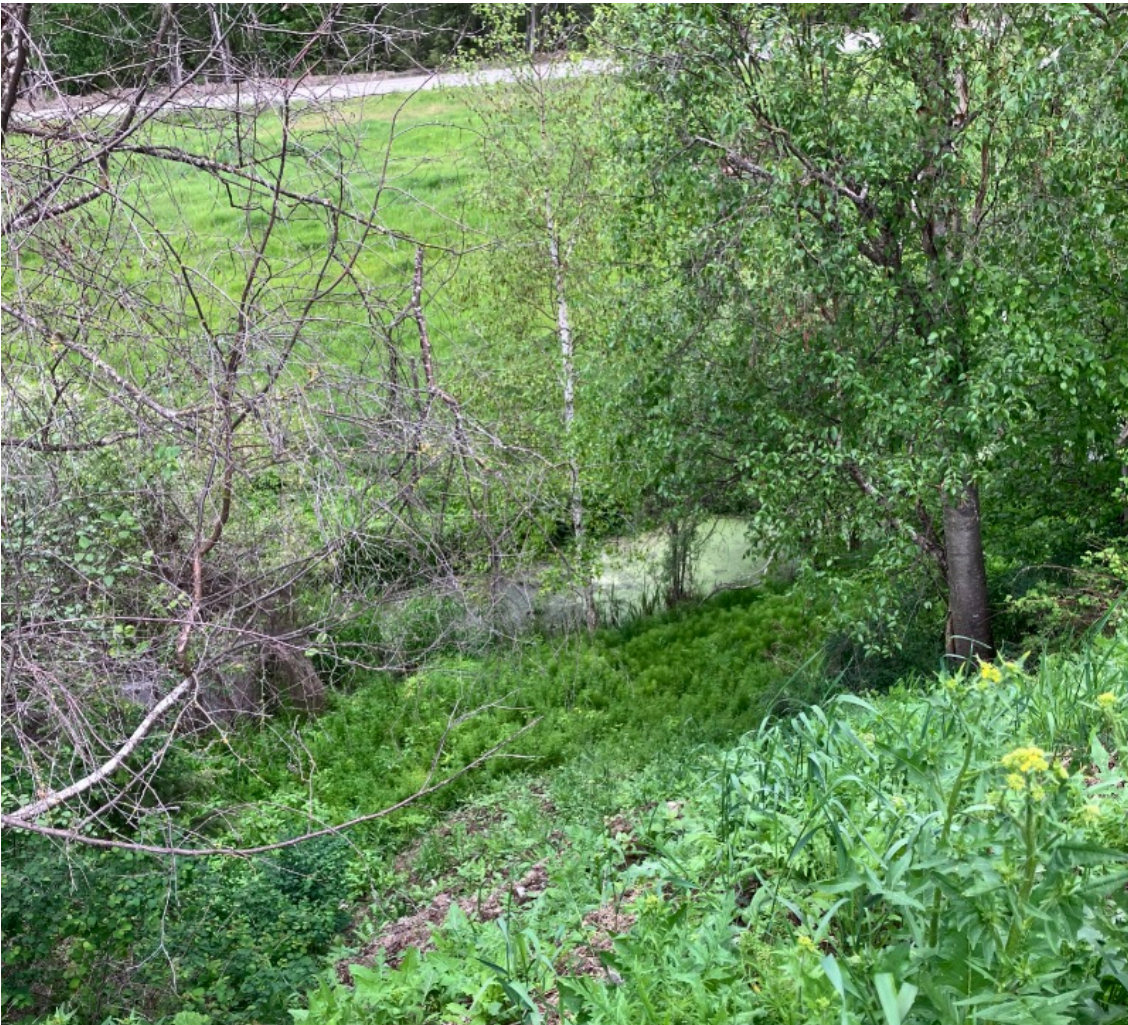
Photo 6. Ditch located adjacent to the bank and drainage pipe.

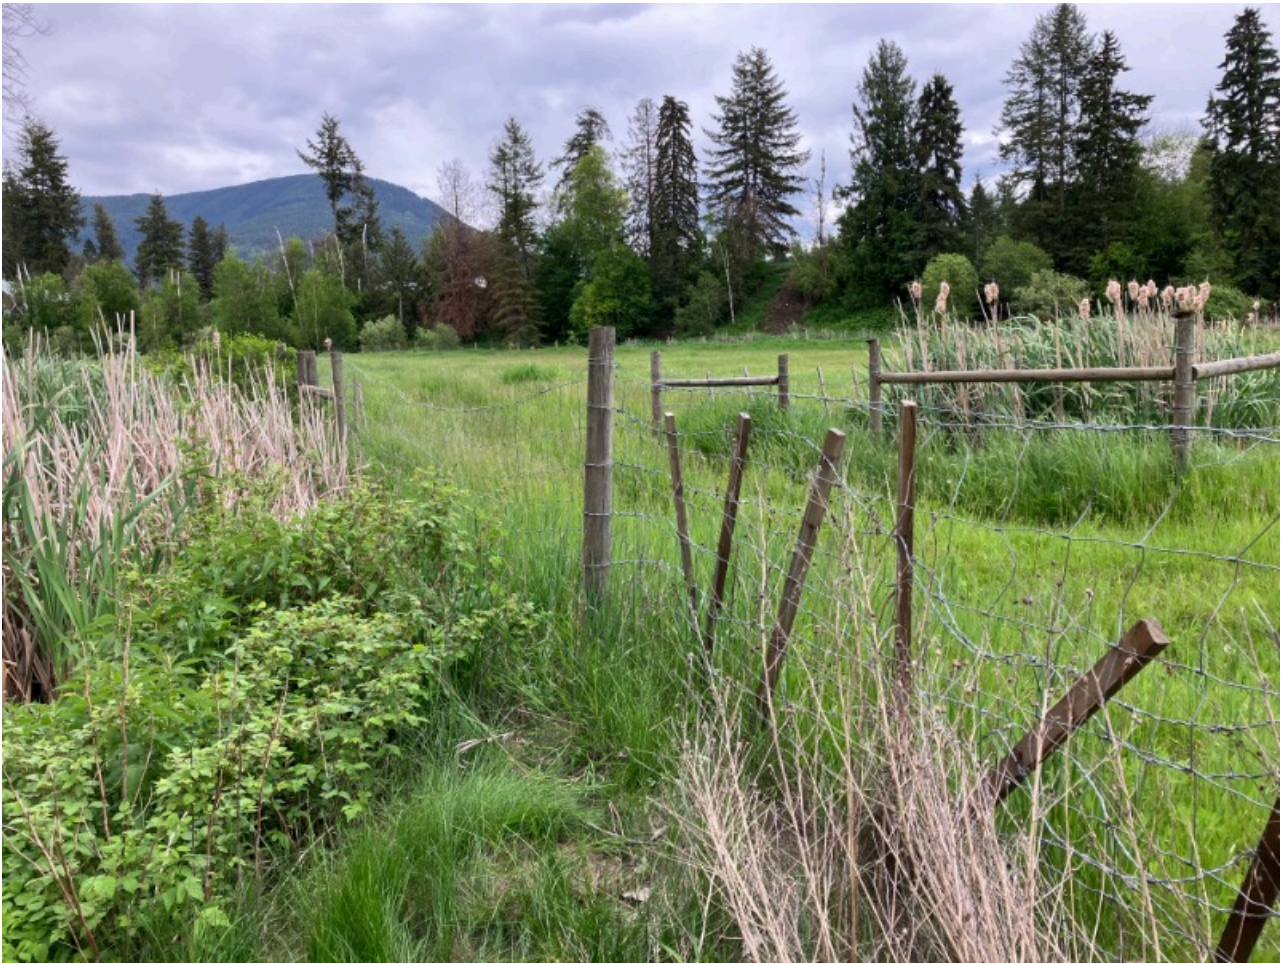
During the on-site inspection, Ministry Staff observed a) that livestock did not have direct access to a drinking water source or watercourse. b) a ditch containing contaminated runoff, released by a drainage pipe from a confined livestock area, was within 8 metres of the property boundary (Photo 7); however, Ministry Staff could not confirm whether contaminated runoff went below the water table, resulting in contaminated runoff crossing the property boundary and entering a watercourse, specifically the Shuswap River. Ministry Staff observed contaminated runoff from the drainage pipe, crossing a property boundary northwest of the Facility onto a neighbouring field (Photos 1, 5, 6 and 8). Ministry Staff did observe c) that the accumulation of manure, animal bedding and feed was not managed to prevent contaminated runoff and solids from escaping; the drainage pipe observed in the confined livestock area enabled contaminated runoff to escape (Photo 3). d) contaminated runoff that escaped the area was not collected and contained and discharged directly to land. Ministry Staff could not confirm if contaminated runoff were discharged directly to a watercourse. Therefore, Carson Farm is out of compliance with Sections 62(b), 62(c), and 62(d)(i) and (ii) of COPAEM.

Photo 7. Ditch containing contaminated runoff 7 metres within the property boundary.

Carson Farm must immediately cease the discharge of contaminated runoff directly to ground and must cease and prevent contaminated runoff, leachate and solids from escaping, entering a watercourse, crossing a property boundary or going below the water table.

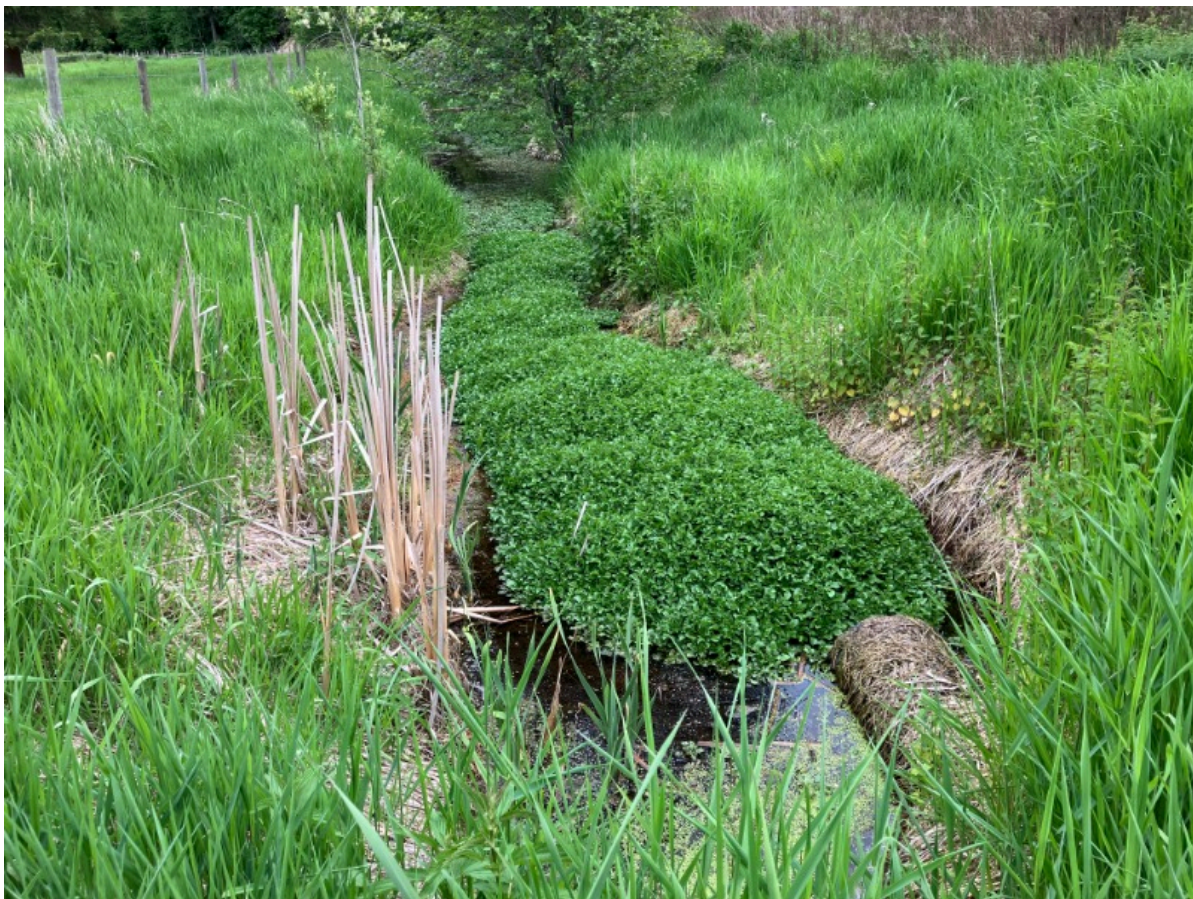
Photo 8. Ditch containing contaminated runoff from confined livestock area drainage pipe.
