Re: Non-compliance Advisory Letter

On July 21, 2025, the Ministry of Environment and Climate Change Strategy (Ministry) Environmental Protection Officer Rebecca Benham (Ministry Staff) conducted an on-site inspection of KT Ranches, also known as Carson Farm (KT Ranches) agricultural operation located at 125 Sugar Lake Road, Lumby, BC (Facility). The inspection was conducted in response to a complaint regarding the Facility's management of manure and to verify compliance with the Code of Practice for Agricultural Environmental Management (COPAEM). Present during the inspection was Kevin Carson (Owner, KT Ranches). Supplemental information for the inspection was provided by the Owner via email.

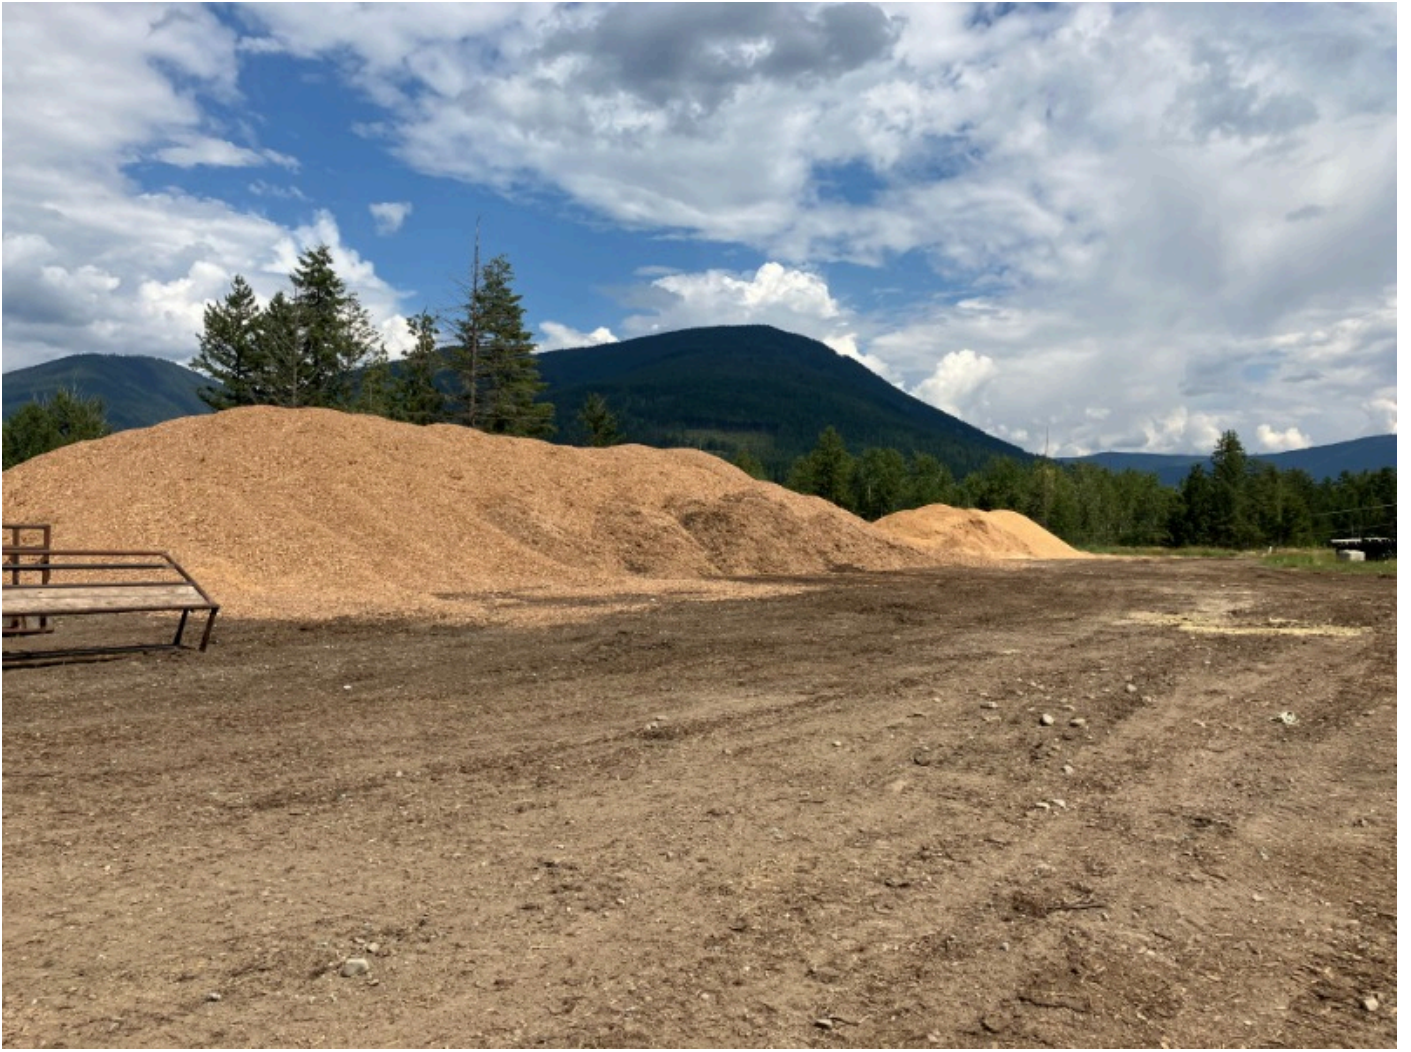
Photo 1. Wood chip storage area outside the setback distances listed in section 17.

During the on-site inspection, Ministry Staff observed wood residue being stored as temporary field storage. The Owner informed Ministry Staff that wood residue is used in the agricultural operation within 12 months.

During the on-site inspection, Ministry Staff observed wood residue being stored as temporary field storage. The Owner informed Ministry Staff that wood residue is used for animal bedding for the confined livestock areas. Ministry Staff did not observe runoff or leachate being produced from the storage of wood residue and is not located in a low-lying area prone to flooding or an area in which there is standing water or water-saturated soil.

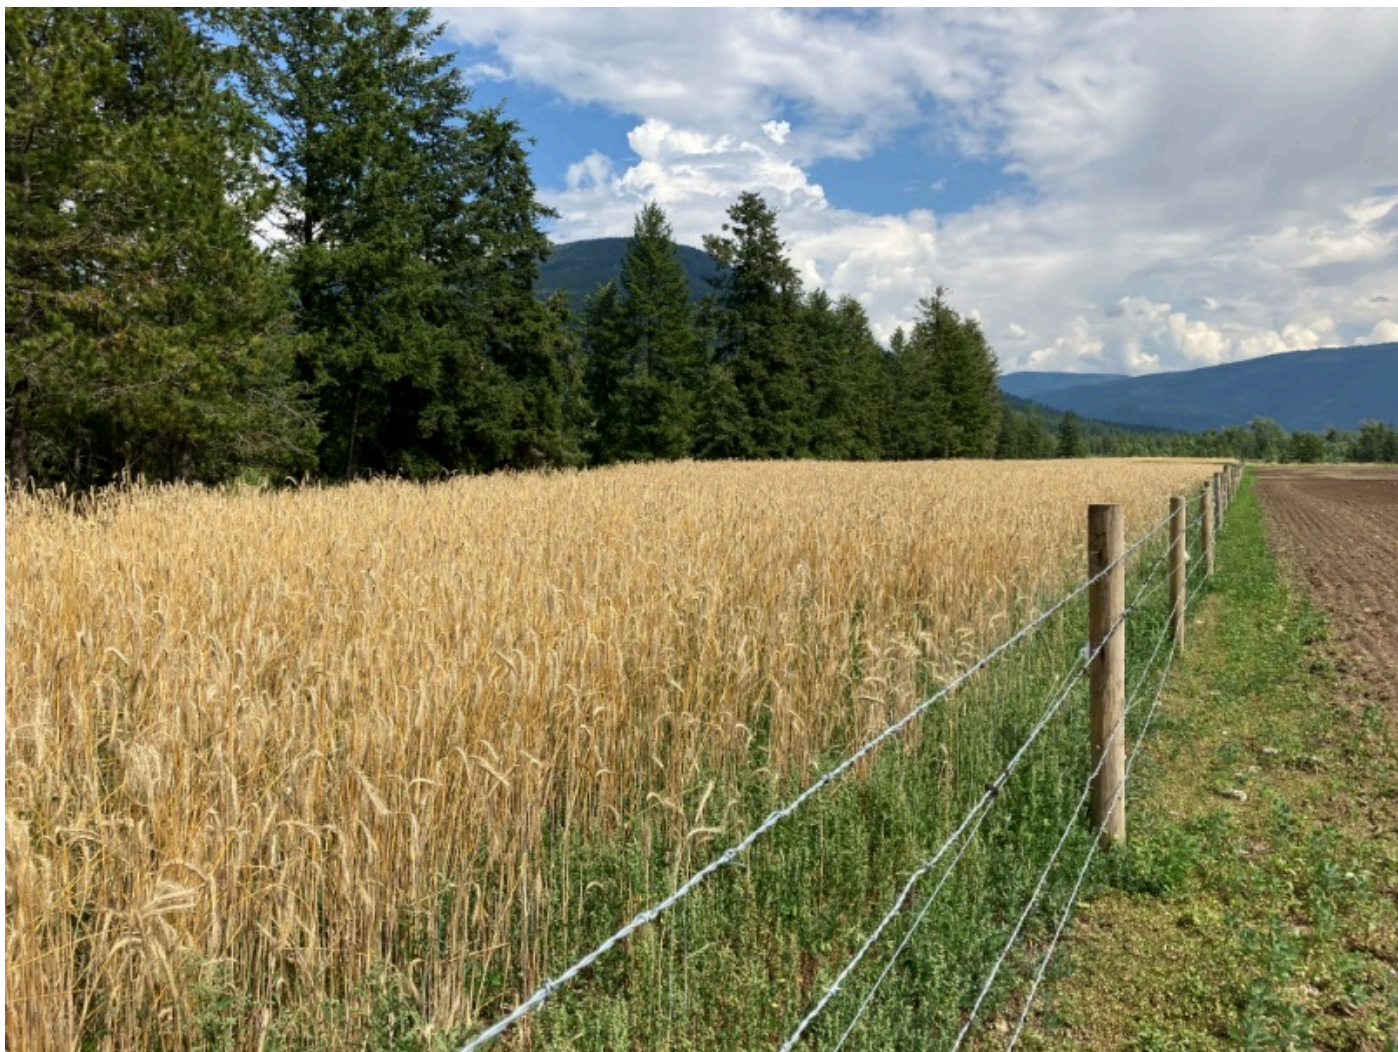
Photo 2. Observed confined livestock areas outside the setback distances listed in section 17.

During the on-site inspection, the Owner informed Ministry Staff that the Facility keeps livestock using a confined livestock area. Ministry staff observed the confined livestock areas and confirmed they were outside the setback distances listed in Columns 2, 3, and 4 of section 17(6)(b) of COPAEM. Ministry Staff accessed the online BC Groundwater Well database and the online iMAP watercourse map layer and confirmed the groundwater wells and watercourses were outside the setback distances listed in Columns 2, 3, and 4 of section 17(6)(b) of COPAEM.

COPAEM defines "confined livestock area" as "an outdoor area, other than a grazing area, seasonal feeding area or temporary holding area, where livestock are confined by structures or topography". During the on-site inspection, Ministry Staff observed the cattle were confined to an outdoor pen structure, and do not have direct access to a drinking water course or watercourse. Ministry Staff observed that the accumulation of manure, animal bedding and feed is managed to prevent runoff, leachate, and solids from escaping. During the on-site inspection, Ministry Staff also observed that runoff, leachate, and solids did not escape the area and were not discharged to directly to land or water.

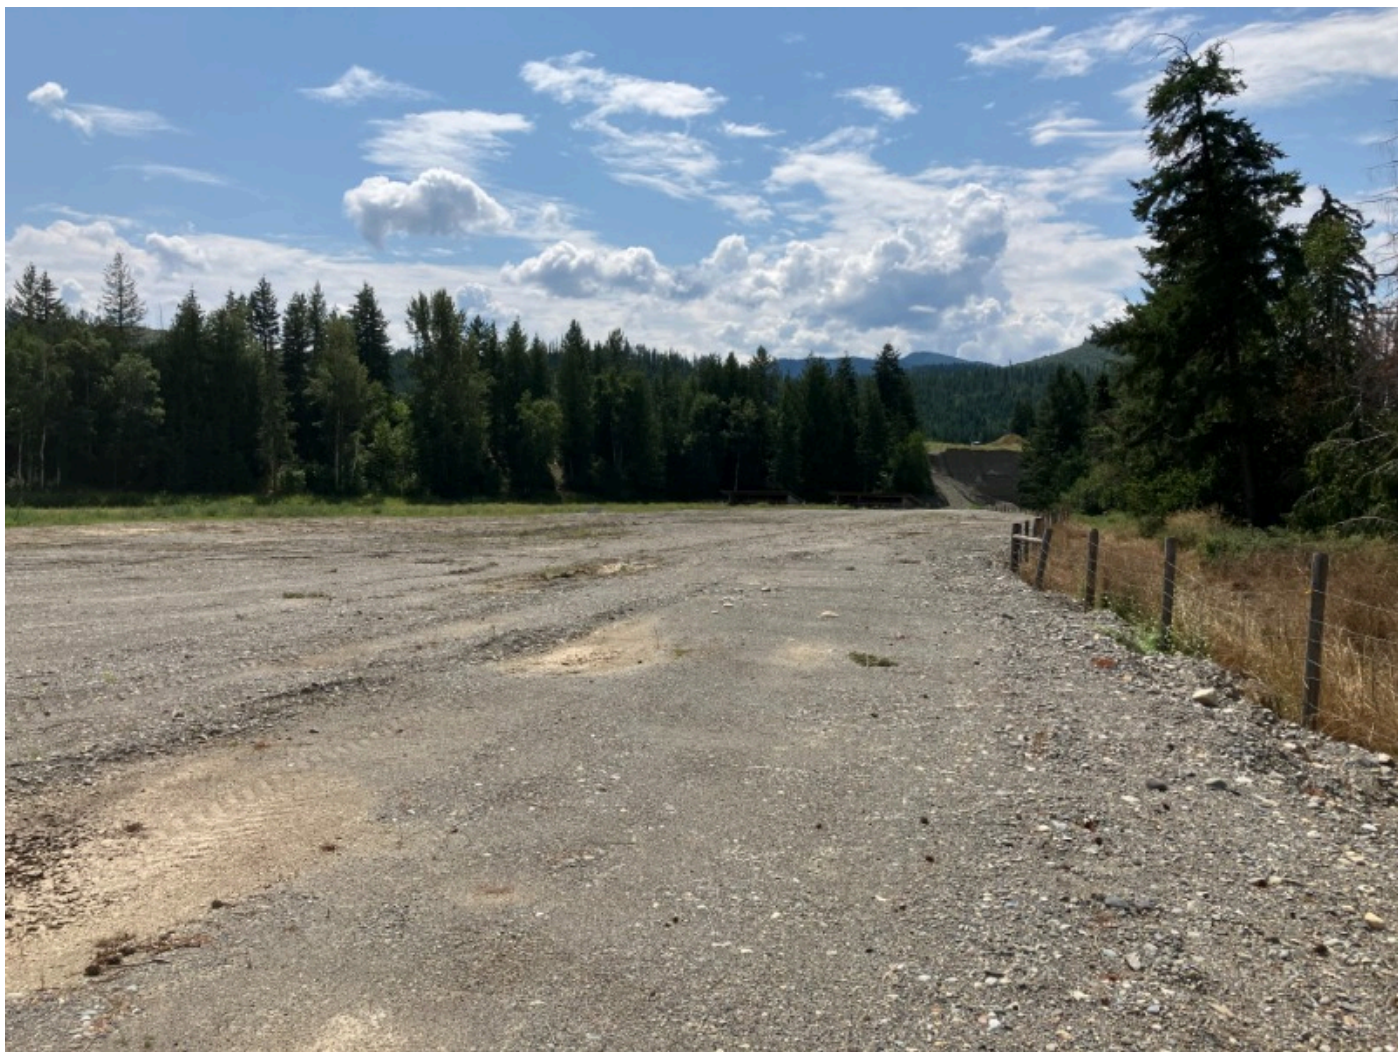
Photo 3. Observed decommission feedlot observed west of the Facility.

During the on-site inspection, Ministry Staff observed a clear area which was previously used as a feedlot for growing cattle had been decommissioned. The Owner informed Ministry Staff, in the Information Response Email, that the manure pack had been removed from the decommissioned feedlot and stored using a temporary field storage until applied to land in accordance with COPAEM. During the on-site inspection, the Owner also informed Ministry Staff that leachate did not enter groundwater or a watercourse.

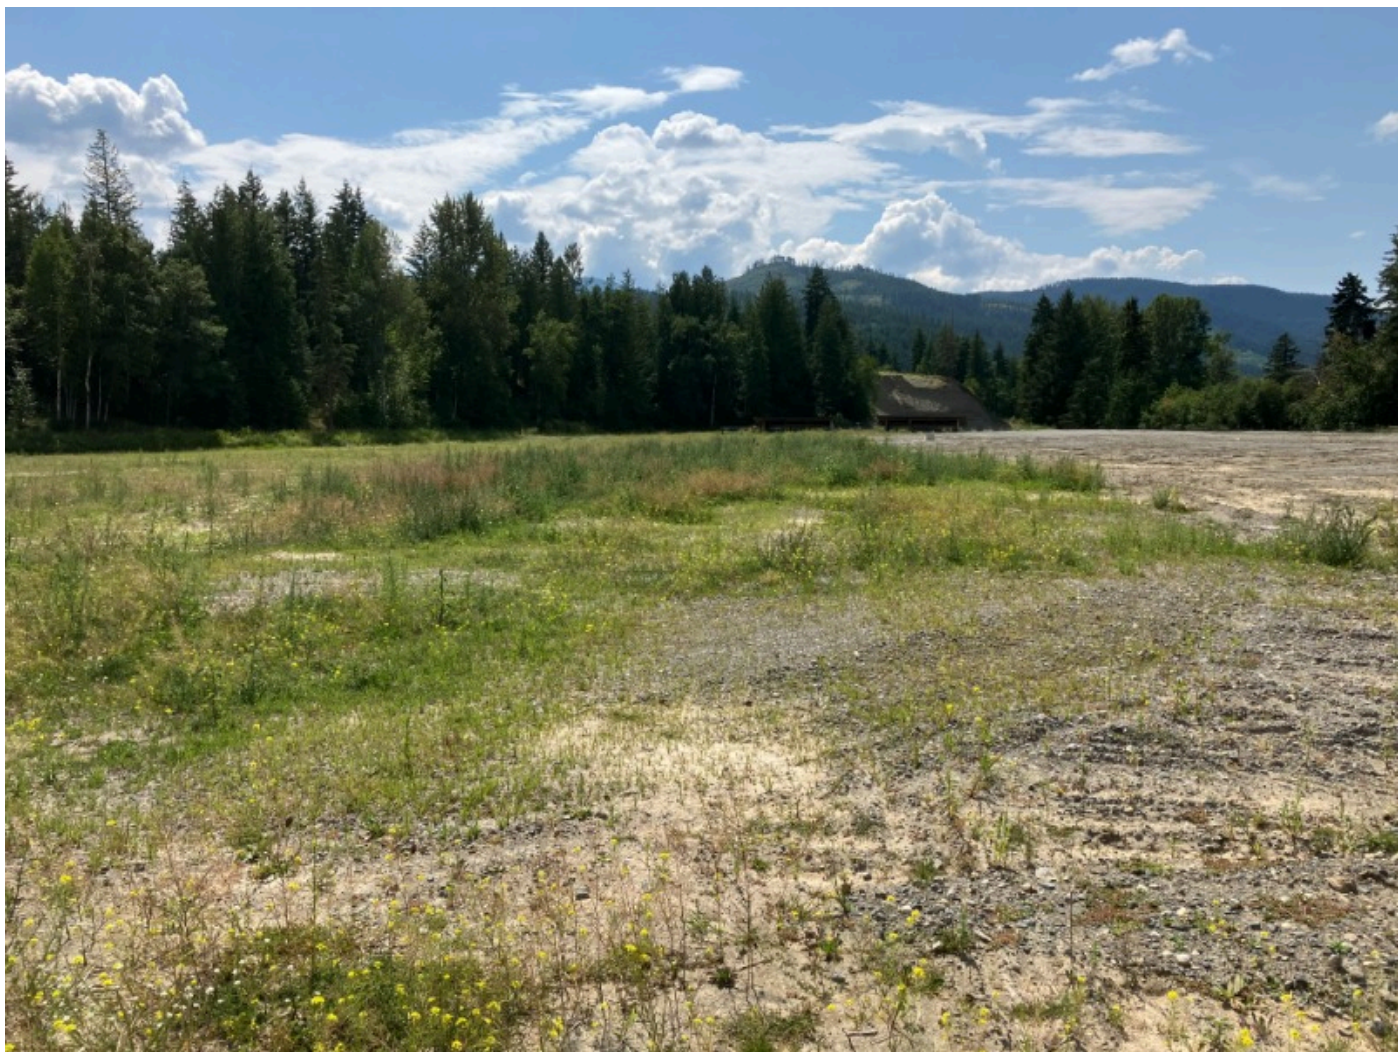
Photo 4. Decommissioned feedlot observed west of the Facility.
